WOOD DESTROYING ORGANISM

Structure(s) on Property Inspected: Single Family Residence, Guest Cottage and Detached Garage Only

WOOD-DESTROYING ORGANISMS INSPECTION REPORT

Termite Depot
Inspection Company Name Business License Number: JB279986
3131 St. Johns Bluff Rd S
Company Address Phone Number: (844)553-3768
Jacksonville, FL 32246
Company City, State and Zip Code Date of Inspection: 03/06/2024

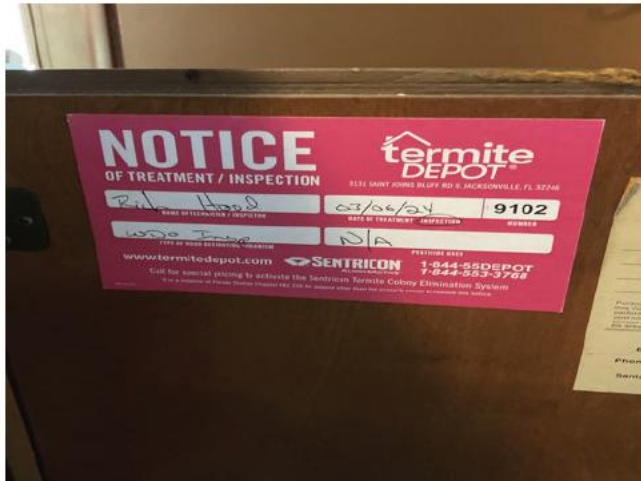
WDO Inspection Notice

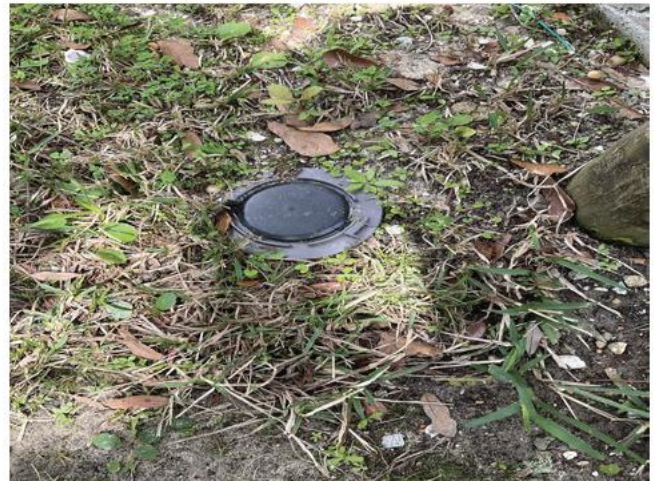
EVIDENCE of previous treatment observed: Yes No If Yes, the structure exhibits evidence of previous treatment. List what was observed:
Observed Trellona termite bait stations.
(State what visible evidence was observed to suggest possible previous treatment - use additional page if necessary)

Trelona termite bait stations

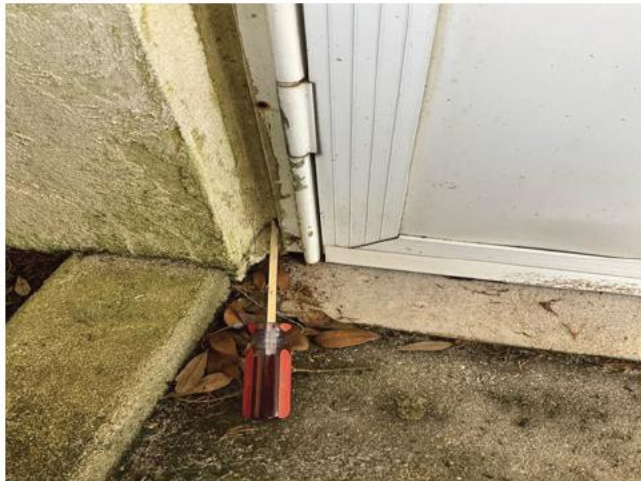
Wood Decay Front Door Frame Left

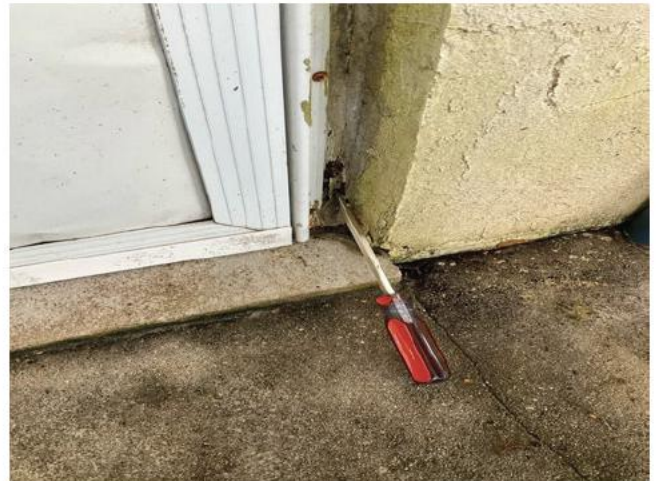
Wood Decay Front Door Frame Right

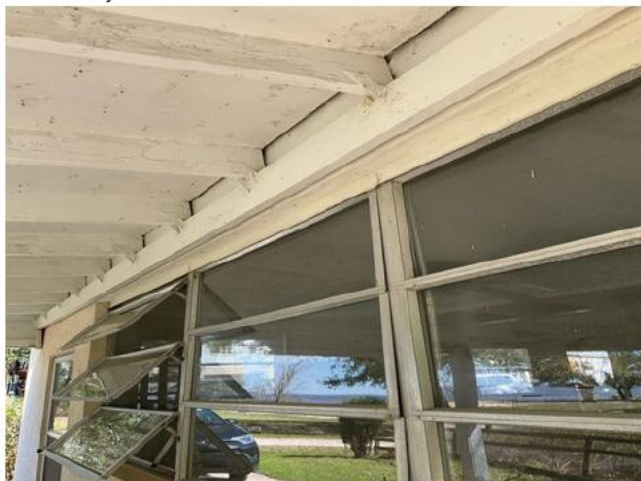
Wood Decay Right Side Window Frame/Upper Half/Various Areas

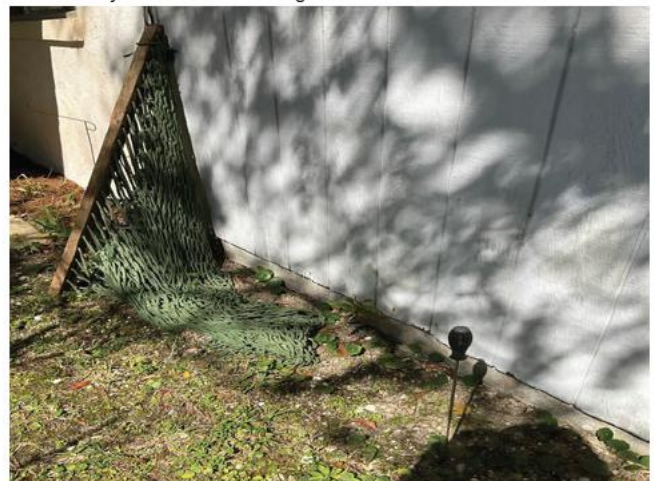
Wood Decay Right Side Siding/Lower Half/Various Areas

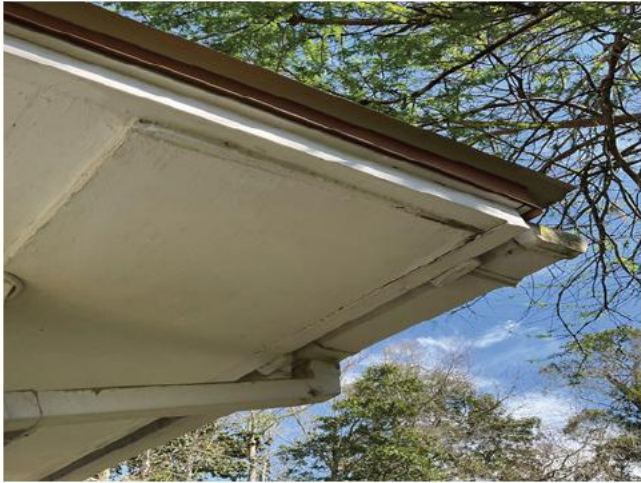
Wood Decay Right Side Eave Near Rear

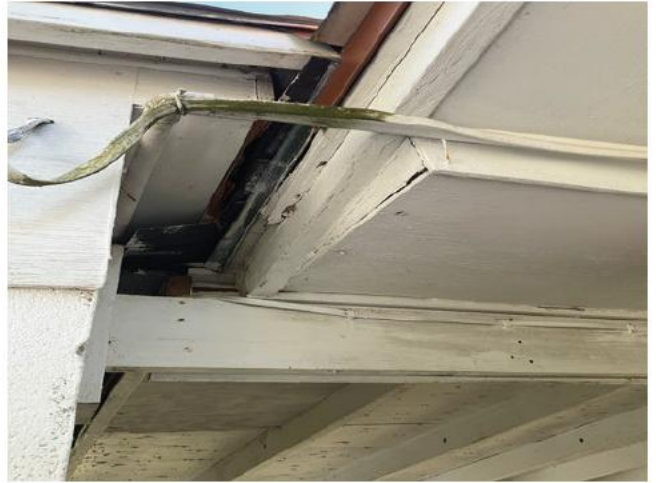
Wood Decay Rear Eave/Cottage And Main Connection

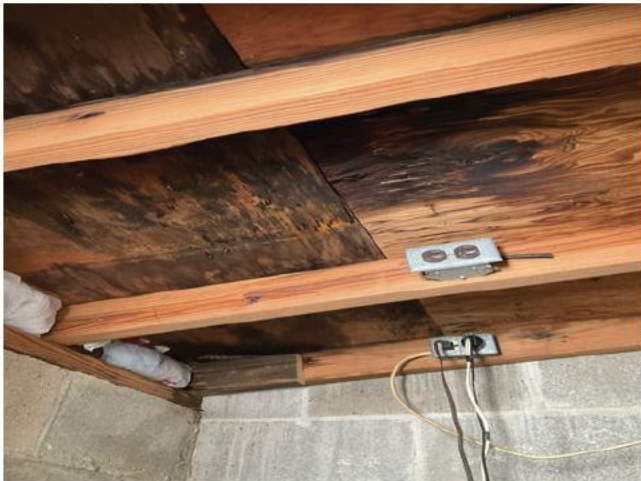
Wood Decay Well House Roof Sheathing

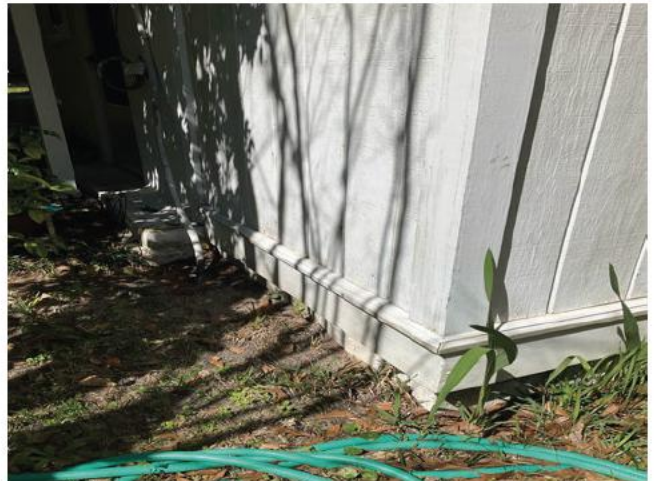
Wood Decay Cottage Siding Front/Lower Half/Various Areas

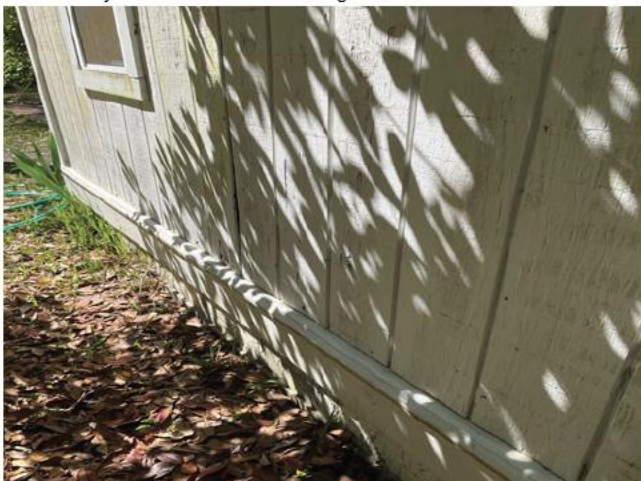
Wood Decay Cottage Siding Right Side/Lower Half/Various Areas

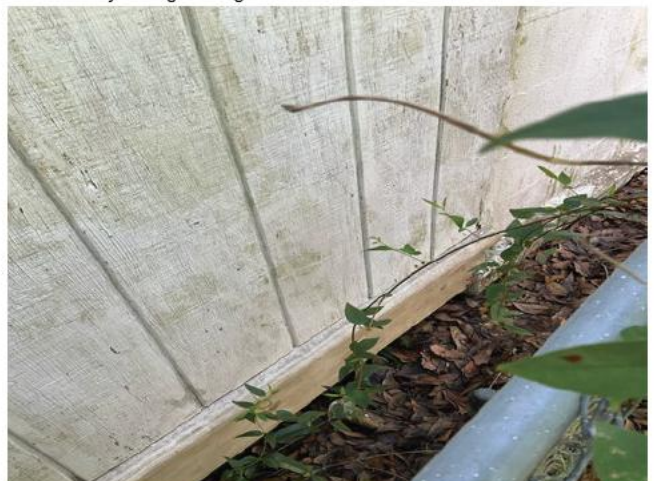
Wood Decay Cottage Siding Rear/Lower Half/Various Areas

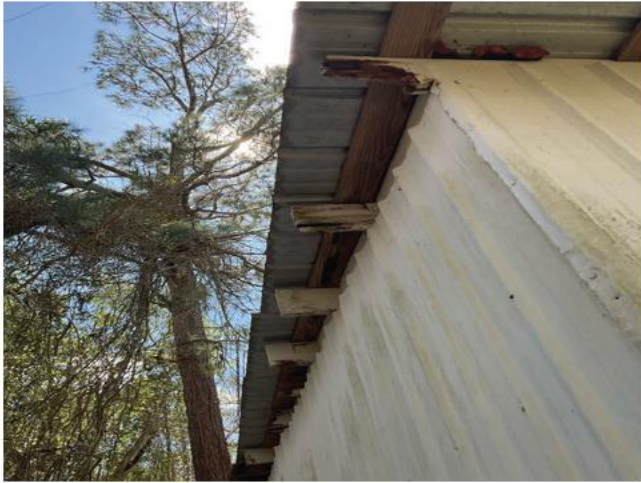
Detached Garage Rear Rafters/Eave At Various Areas

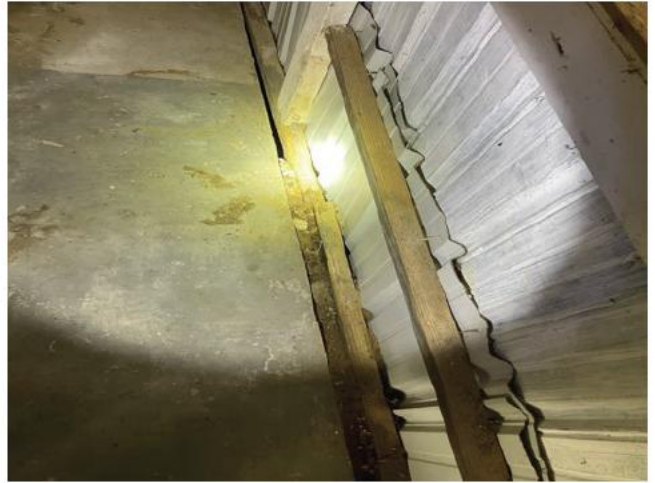
This house or portions of this house are built with wood framing, covered by stucco or siding, which extends to, or into the ground. This combination is a primary feature Subterranean Termites use to enter the house undetected. To determine if Subterranean Termites are currently in these locations, the stucco would have to be cut somewhere between ground and floor level and the stucco removed from under that cut. If siding is present, the siding would have to be removed between floor & ground level, or the ground level lowered to expose the stem/foundation wall. Ground should not be removed if it results in a trench against the foundation/stem wall that would allow water to collect. Once these procedures are performed these areas could then be re-inspected to see if Subterranean Termite activity is present in these areas. Additionally, these areas could then be inspected for mud (shelter) tubes or their residue. If mud tubes or mud tube residue is present, there is a possibility that hidden damage exists in those areas to wall framing and wall sheathing etc. If termites or mud tubes are present, we would recommend treatment. Treatment can be by liquids or baits and typically carry a one year warranty renewable thereafter on a year to year basis. Some warranties cover re-treatment only while others will repair any "new" Subterranean Termite damage. It is important that any warranty issued be for the entire structure. If the property is currently under a Subterranean Termite warranty, we would recommend that you contact the treating company immediately, so they may take any actions that they might deem appropriate in accordance with their policies. It is very important to take careful measurements to make sure exterior wall coverings are only removed from areas that are below the level of the slab. Removal of external wall coverings above slab level may result in water intrusion and much worse.

Inspection Limited/Earth To Wood Contact/Detached Garage Perimeter

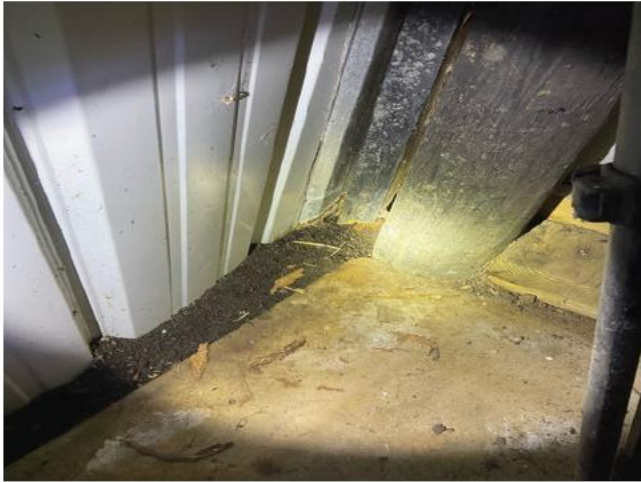
Wood Decay Detached Garage Perimeter/Various Areas

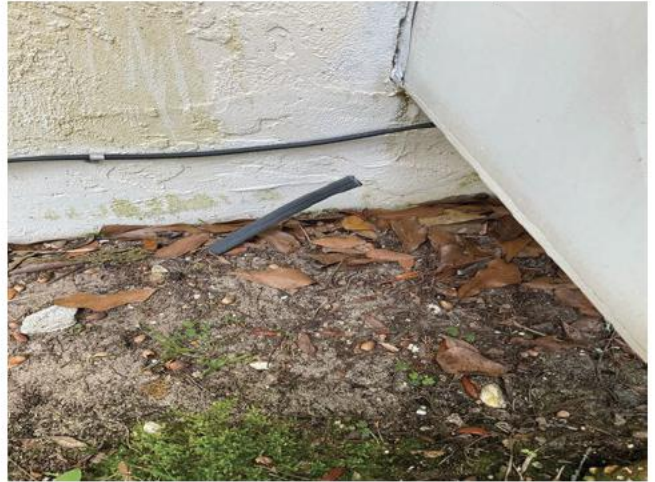
Inspection Limited
