# HUD Engineering Certification Report

Prepared for: [REDACTED]

HUD Engineering Certification Report Summary

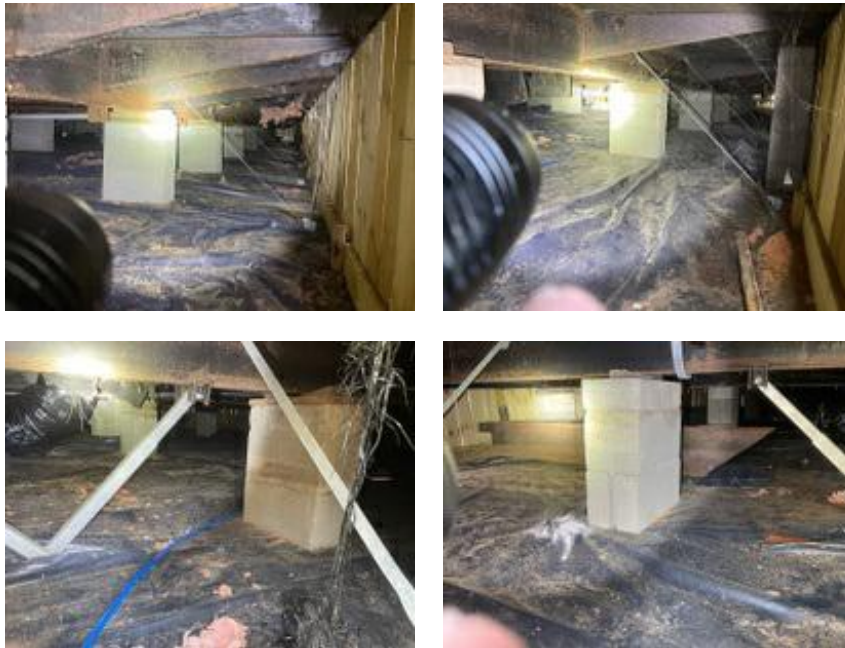
**1.17 Foundation Type Images**

Concrete Masonry Units

Plastic Pad

We observed that the manufactured structural frame of this Double-wide house is supported permanently to a foundation in the crawlspace. We observed that horizontal and vertical uplift restraint had been provided at various locations. The manufactured frame had been fastened to the foundation adequately. The overall integrity of the foundation was in good condition. Based on the information observed, we are of the opinion that the house foundation has been constructed in accordance with HUD/FHA Guidelines - Permanent Foundation Guide for Manufactured Housing; September, 1996. The foundation meets HUD guidelines for manufactured housing dated Sept 1996.

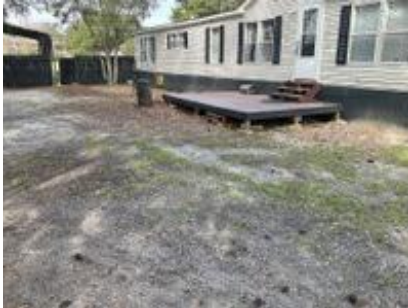
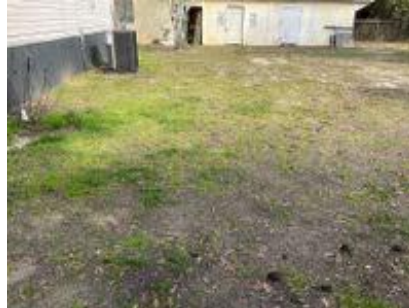
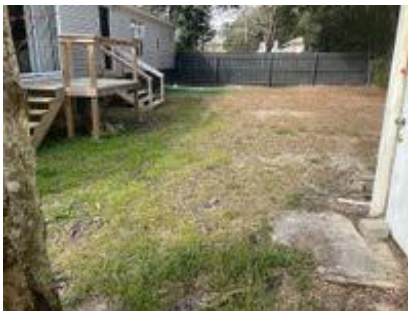
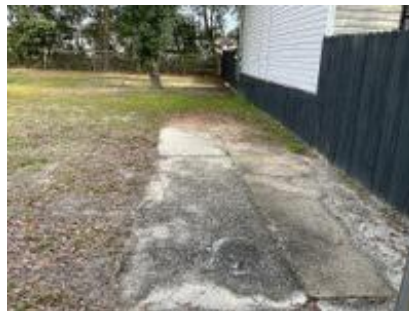
### **2.2 Exterior Grading Images**

Grading is flat but no adverse conditions were noted.

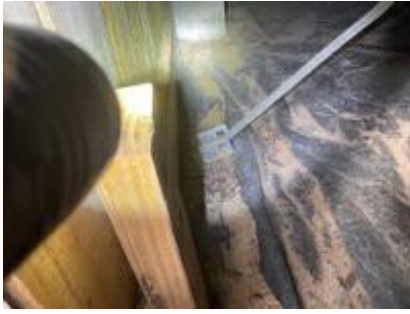
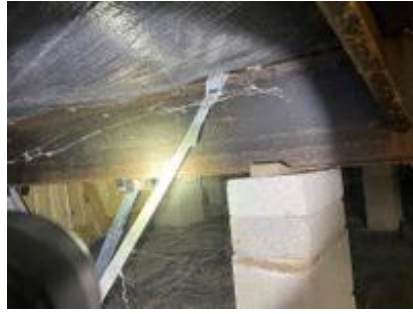
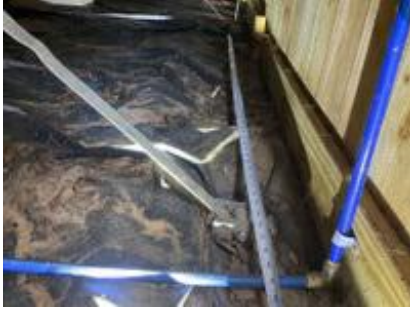
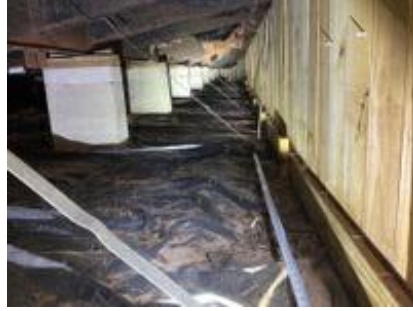
2.5 Anchor Method Images

Metal Straps connected to anchors augured into the soil (spacing every 5 feet)

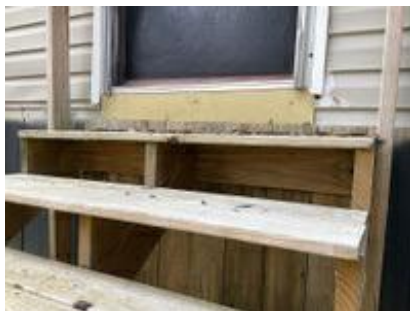
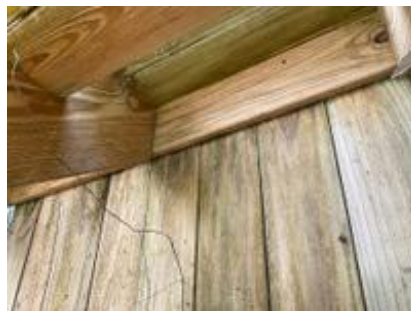
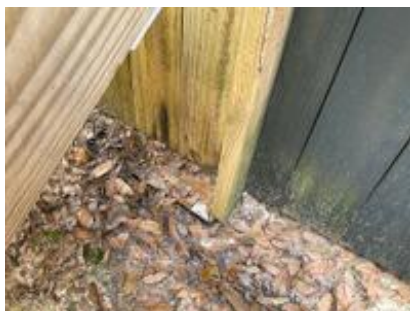
### 3.4 Floor Structure Images

N/A: Stairs are being supported by 2 x 4 posts next to the home and on to plastic pads, no loads are being transferred to the manufactured home.

The Mfd. home **does not appear to have been** modified or altered with respect to this addition.

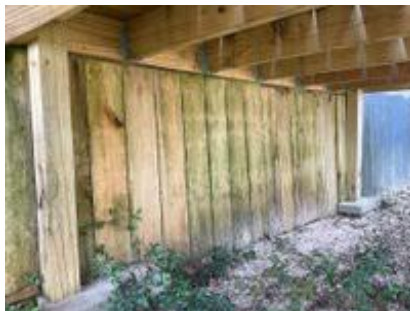
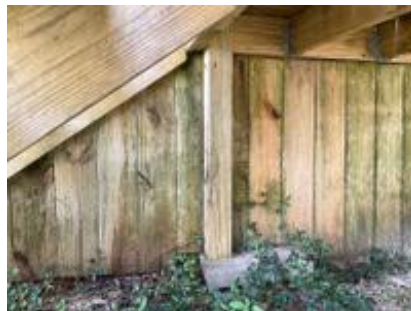
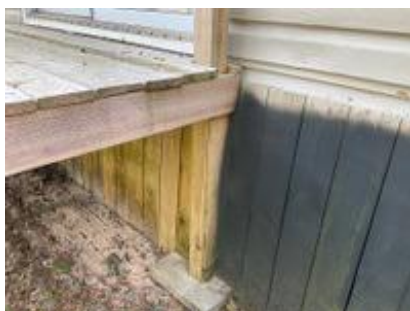
**3.10 Floor Structure Images**

N/A: Loads from deck are being supported by 4 x 4 posts next to the home and onto concrete pads, no loads are being transferred to manufactured home.

The Mfd. home **does not appear to have been** modified or altered with respect to this addition.

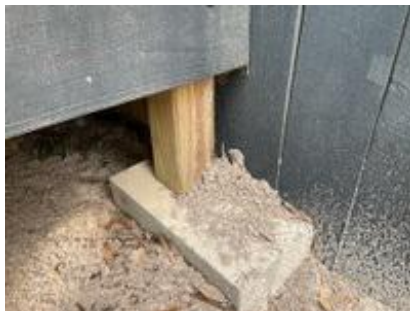
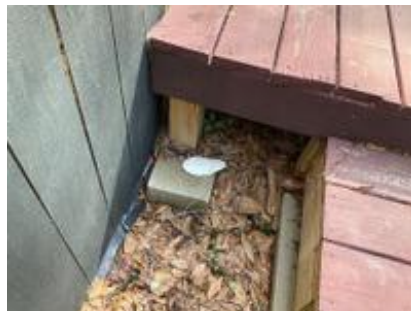
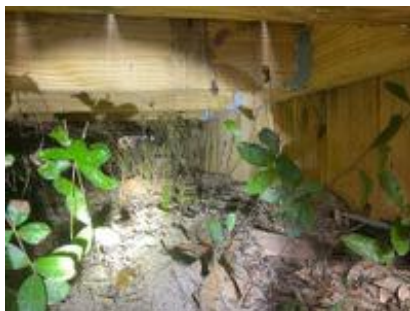
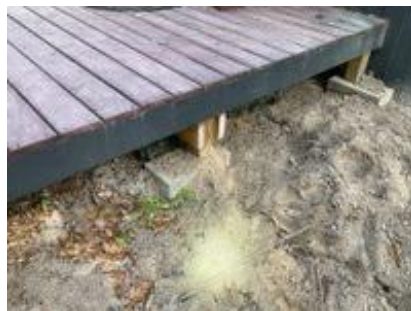
**3.16 Floor Structure Images**

N/A: Loads from deck are being supported by 4 x 4 posts next to the home and on to concrete pads, and no loads are being transferred to manufactured home.

The Mfd. home **does not appear to have been** modified or altered with respect to this addition.
