**HUD
Engineering Certification
Report**

General

HUD Engineering Certification Report Summary

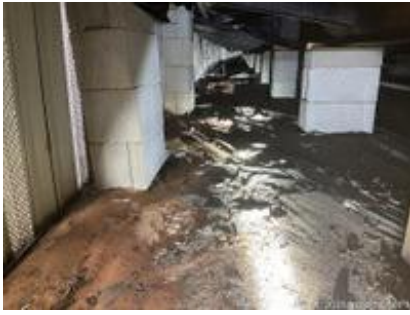
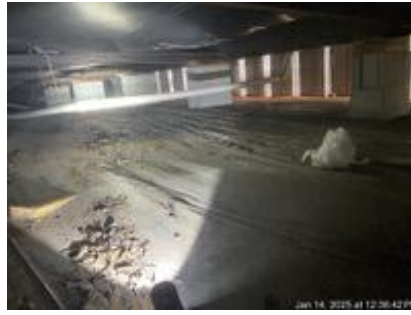
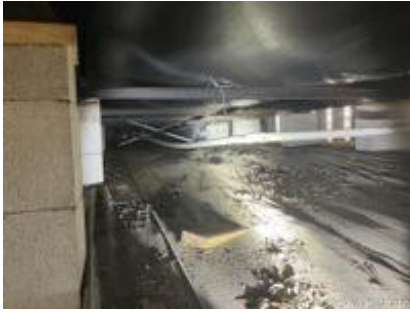
1.16 Foundation Type Images

Concrete Masonry Units

Plastic Pad

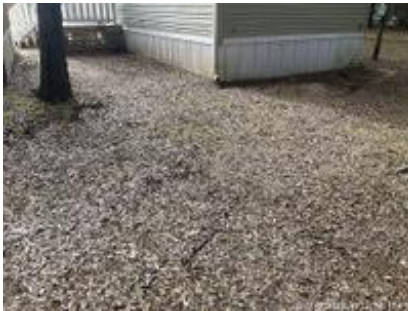
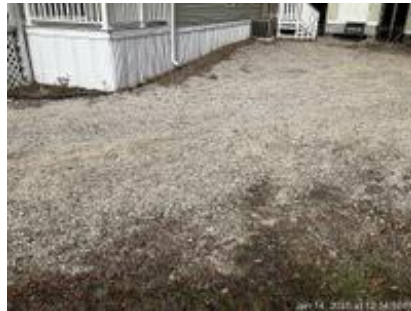
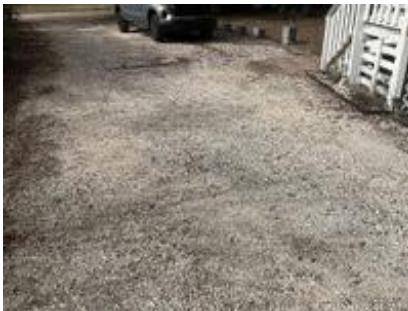
2.2 Exterior Grading Images

Grading is flat but no adverse conditions were noted.

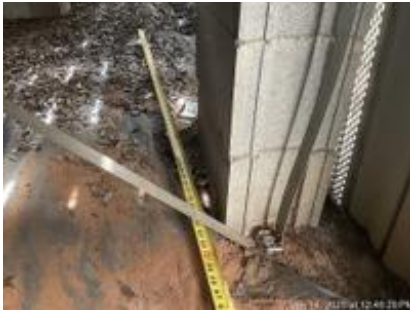
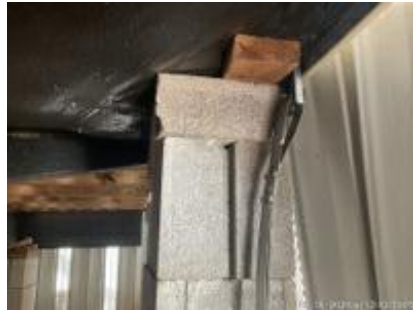
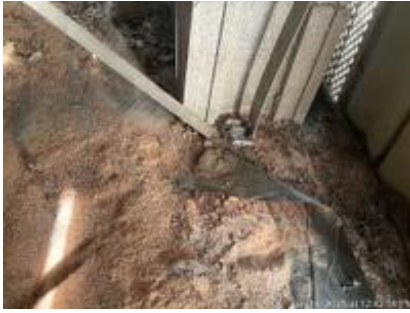
2.5 Anchor Method Images

Metal Straps anchored into a concrete slab and/or footings (spacing every 5 feet)

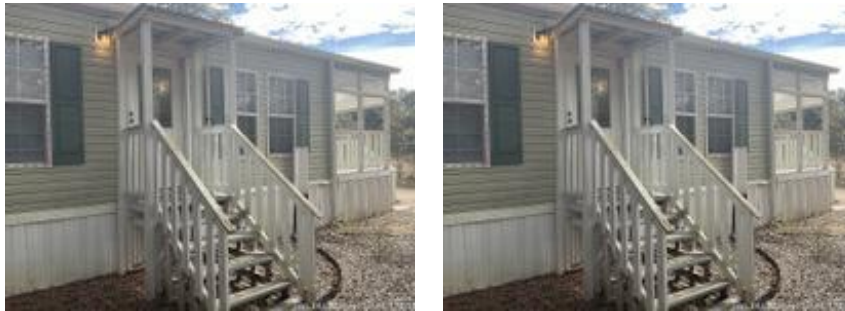
3.2 Images

The Mfd. home **does not appear to have been** modified or altered with respect to this addition.

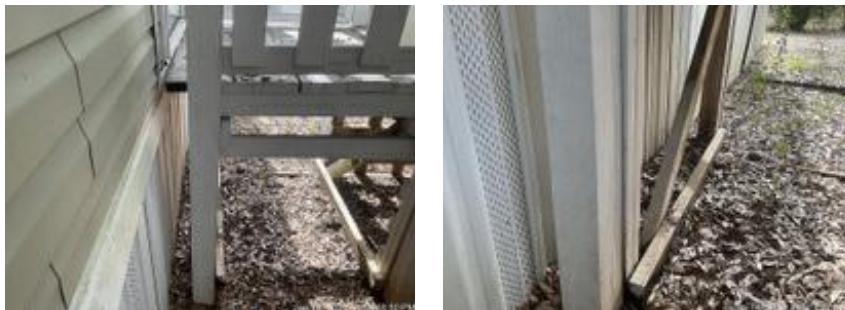
3.4 Floor Structure Images

No loads are being transferred from the floor structure onto the structure of the manufactured home.

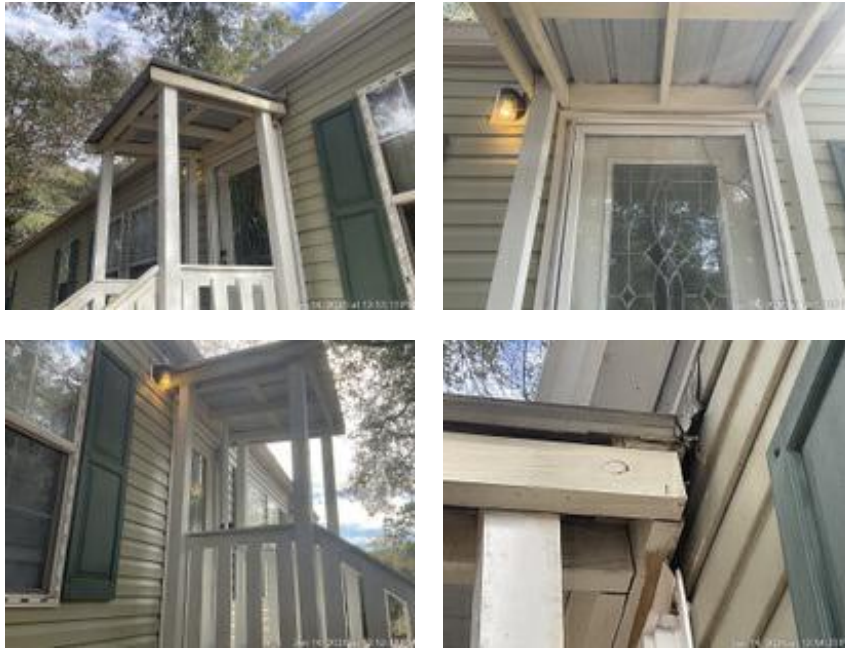
3.6 Roof Structure Images

No loads are being transferred from the roof structure onto the structure of the manufactured home.

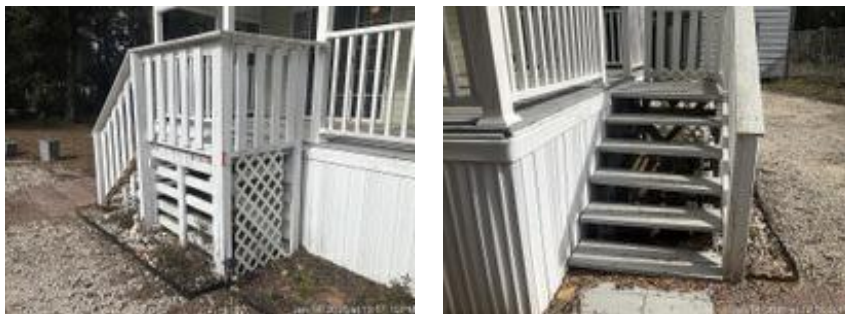
3.9 Images

The Mfd. home **does not appear to have been** modified or altered with respect to this addition.

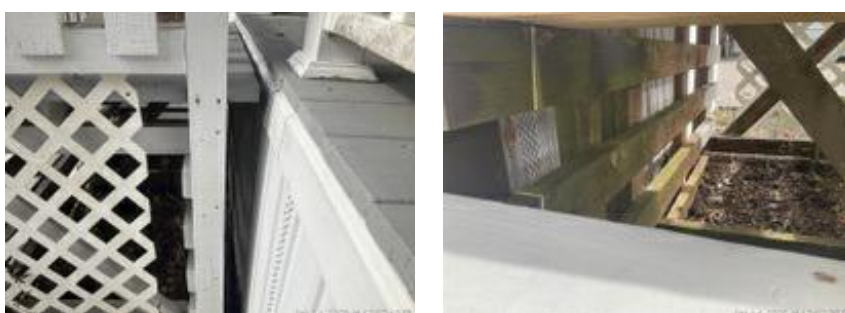
3.11 Floor Structure Images

No loads are being transferred from the floor structure onto the structure of the manufactured home.

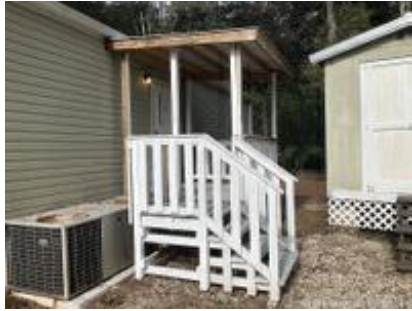
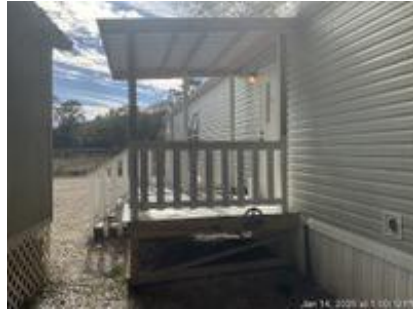
3.15 Images

The Mfd. home **does not appear to have been** modified or altered with respect to this addition.

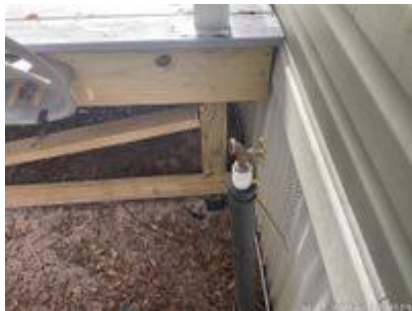
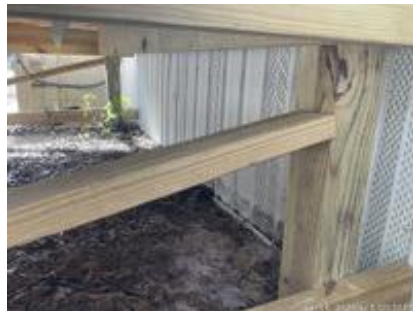
3.17 Floor Structure Images

No loads are being transferred from the floor structure onto the structure of the manufactured home.

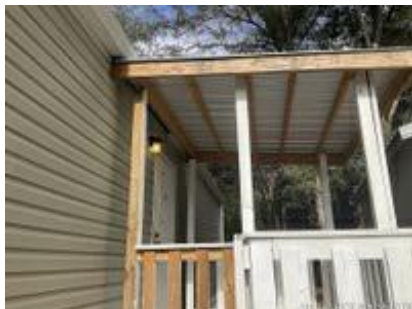
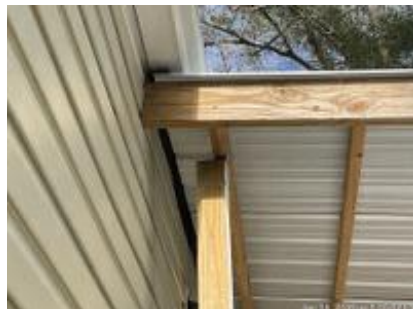
3.19 Roof Structure Images

No loads are being transferred from the roof structure onto the structure of the manufactured home.
