PEACE OF MIND INSPECTION SERVICES

GENERAL HOME INSPECTION

OCTOBER 13, 2022

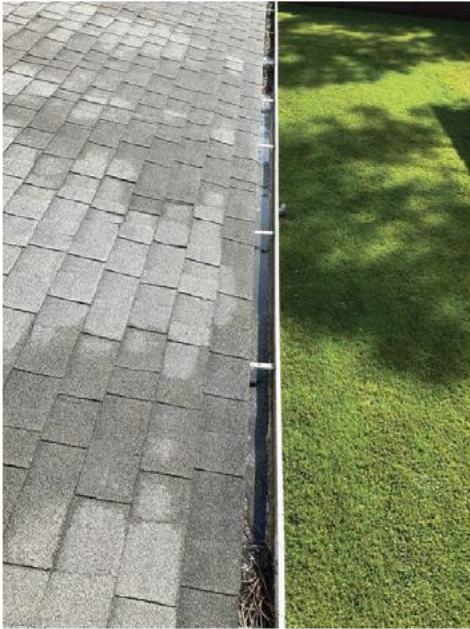
2.3.1 Roof Drainage Systems

DEBRIS

Debris has accumulated in the gutters. Recommend cleaning to facilitate water flow.

Contact a handyman or DIY project

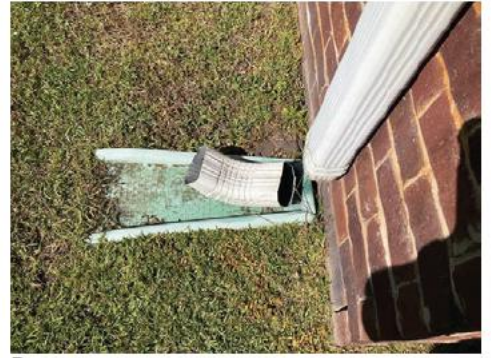
Rear

DOWNSPOUTS MISSING

Home was missing downspouts in one or more areas. This can result in excessive moisture in the soil at the foundation, which can lead to foundation/structural movement. Recommend a qualified contractor install downspout extensions that drain at least 6 feet from the foundation.

Contact a qualified gutter contractor

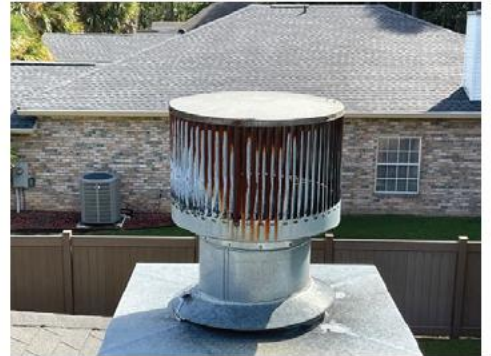
2.5.1 Skylights, Chimneys & Other Roof Penetrations

METAL CHIMNEY RUST

The metal chimney shows evidence of rust and/or rusting. Recommend monitoring the chimney which may have to be replaced at some point.

Contact a qualified chimney contractor.

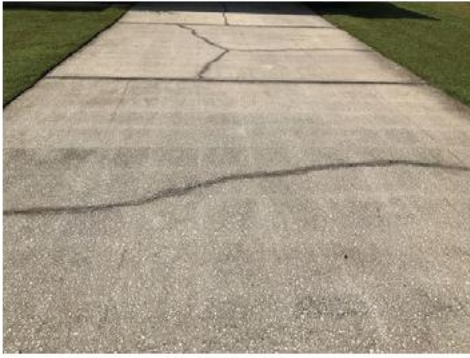
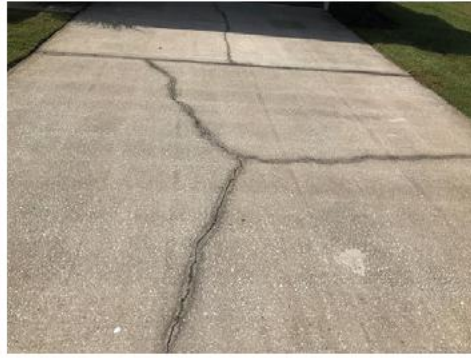
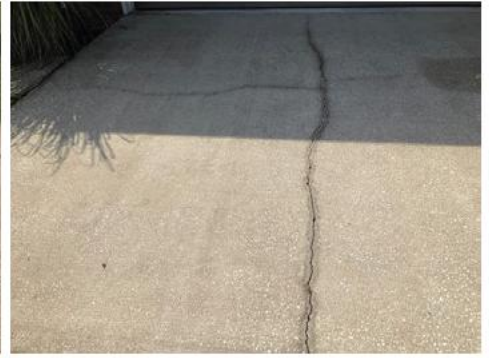
DRIVEWAY CRACKING - MINOR

Minor cosmetic cracks observed, which may indicate movement in the soil. Recommend monitor and/or have concrete contractor patch/seal.

Recommend monitoring.

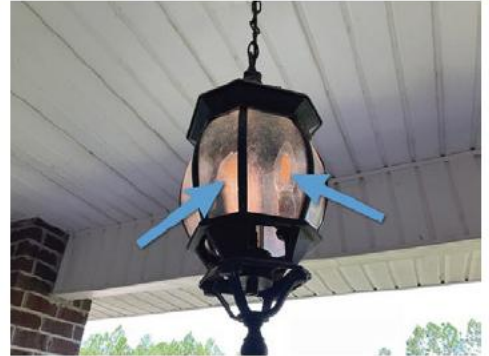
3.1.2 Walkways,
Porches &
Driveways

One or more lights are not operating. New light bulb possibly needed. If its more than a lightbulb change, recommend an electrician evaluate further.

Contact a handyman or DIY project

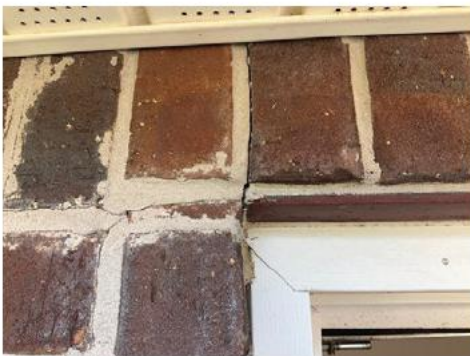
3.5.1 Siding, Flashing & Trim

CRACKING - MINOR

Brick veneer siding showed cracking in one or more places. Recommend monitoring. If it continues, recommend a bonded and licensed contractor to evaluate and repair/replace as necessary.

Contact a qualified masonry professional.

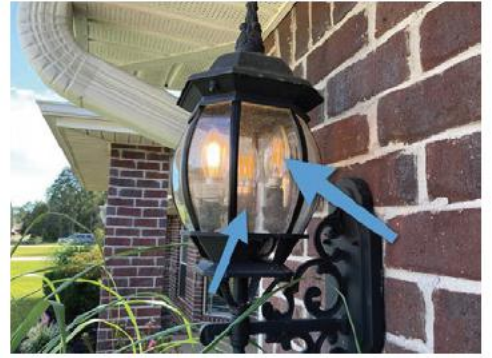
One or more lights are not operating. New light bulb possibly needed. If its more than a lightbulb change, recommend an electrician evaluate further.

Contact a handyman or DIY project

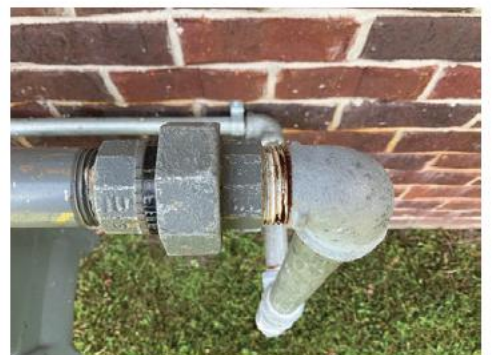
CORROSION

Gas pipes were corroded. This can lead to gas leaks. Recommend contacting local utility company for evaluation and repair.

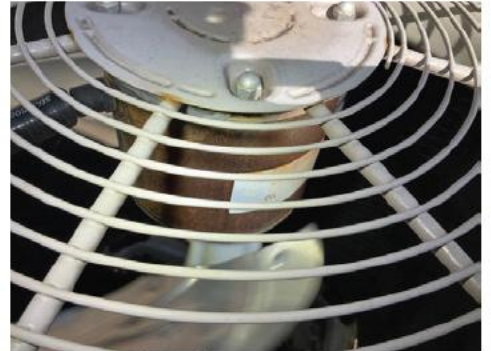
Exterior A/C should be cleaned and serviced annually. Recommend a qualified HVAC contractor clean and service Exterior A/C.

Corrosion found

Contact a qualified HVAC professional.

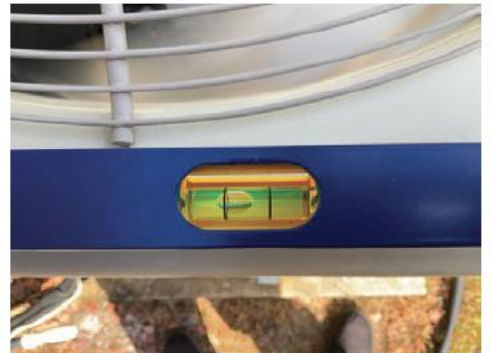
4.1.2 Exterior A/C

If the unit isn't level, then the oil may separate from the refrigerant and end up pooling in the lines and coils. Over time, this can lead to a shortage of oil in the compressor, causing damage and overheating.

Contact a qualified heating and cooling contractor

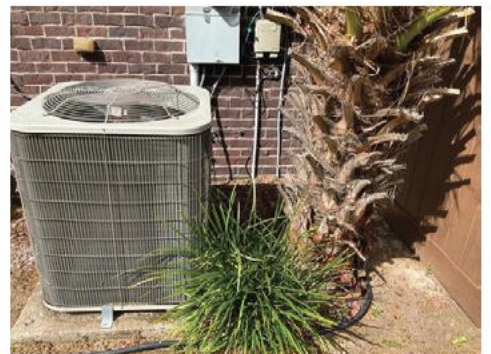
4.1.3 Exterior A/C

Vegetation was too close to the compressor, which can limit heat dissipation and limit effectiveness. Recommend cutting back vegetation to avoid overheating compressor.

Recommended DIY Project

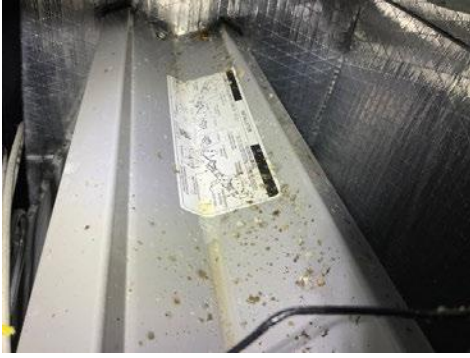
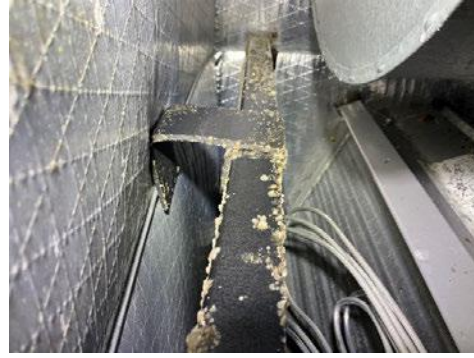
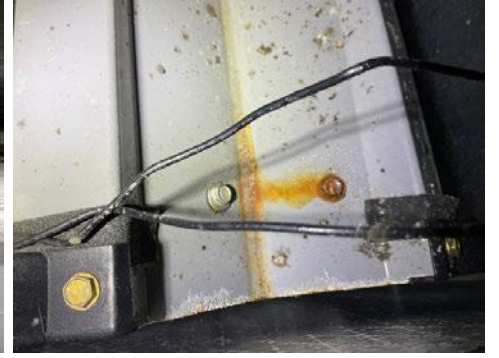
4.2.1 Air Handler

NEEDS ANNUAL SERVICE MAINTENANCE

Contact a qualified HVAC professional.

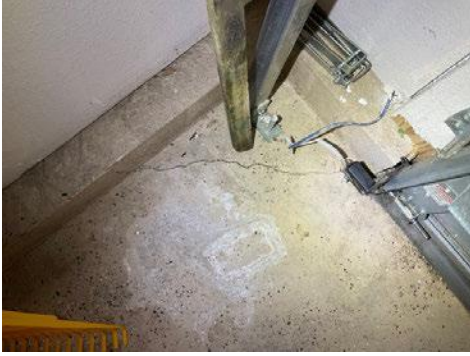
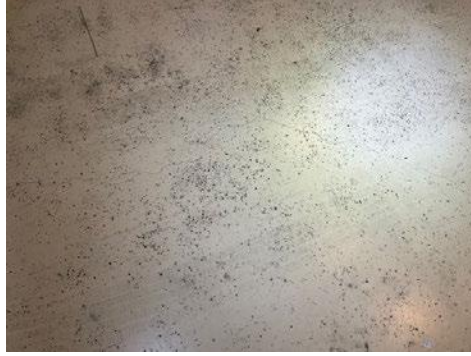
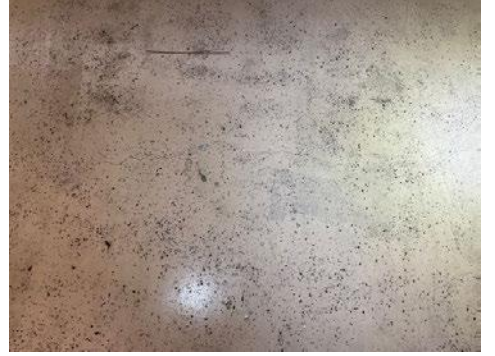
Garage floors had some settlement, but cosmetic in nature. Recommend that cracks be sealed to prevent further damage.

Contact a handyman or DIY project

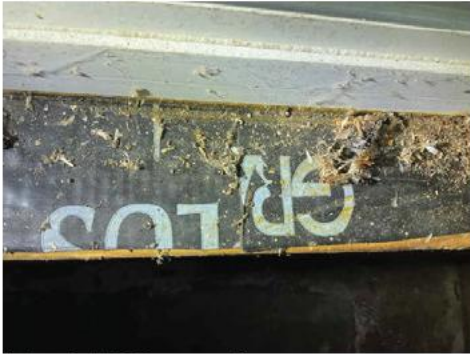
7.3.1 Windows

SUBTERRANEAN TERMITE BODIES FOUND

(also in WDO report)

Contact a qualified pest control specialist.

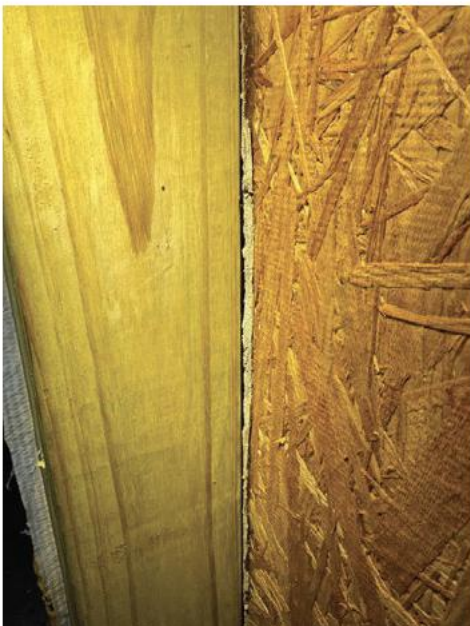
TERMITE MUD TUBES FOUND

Interior side of door right side (also in WDO report)

Contact a qualified pest control specialist.

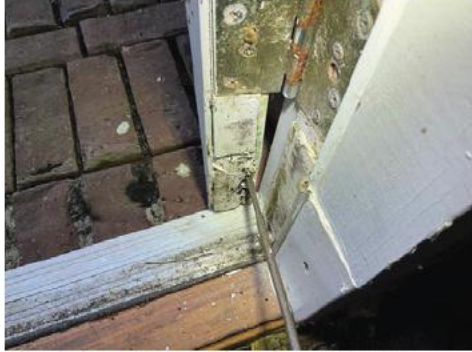
Door sill and/or trim is loose, deteriorated or worn and repair or replacement should be considered.

Shed door right side (also in WDO report)

Contact a qualified professional.

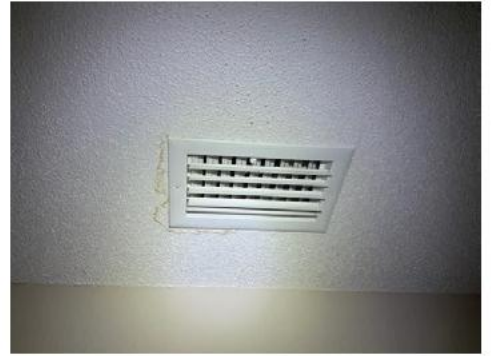
STAIN(S) ON CEILING

There is a stain on ceiling/wall that requires repair and paint.

Source of staining should be determined. It's possible that the condensation build-up occurred prior to the recent HVAC system installation in 2018.

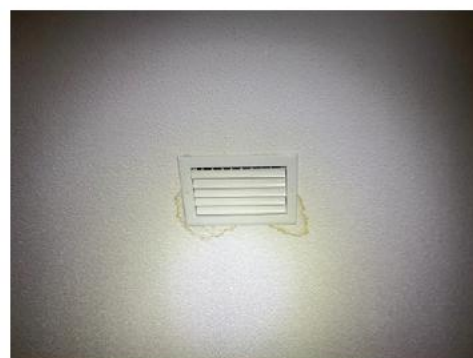
11.1.1 General

STAINS(S) ON CEILING

There is a stain on ceiling/wall that requires repair and paint. Source of staining should be determined. It's possible that the condensation build-up occurred prior to the recent HVAC system installation in 2018.

Contact a qualified professional.

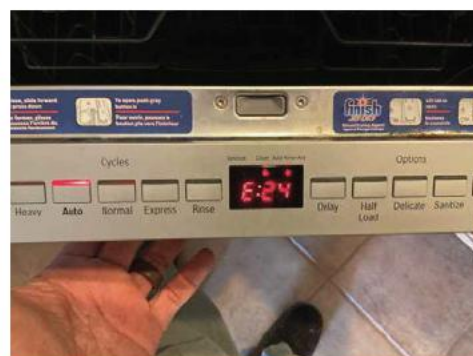
11.2.1 Dishwasher

INOPERABLE

Dishwasher was inoperable using standard controls. Recommend a qualified plumber or contractor evaluate.

Error message

Contact a qualified appliance repair professional.

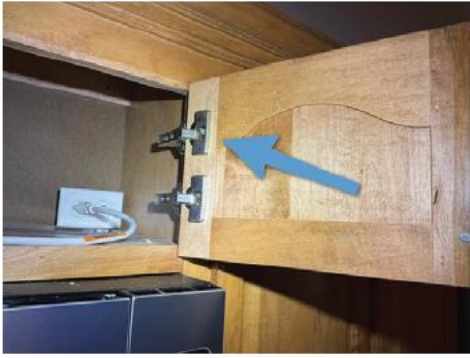
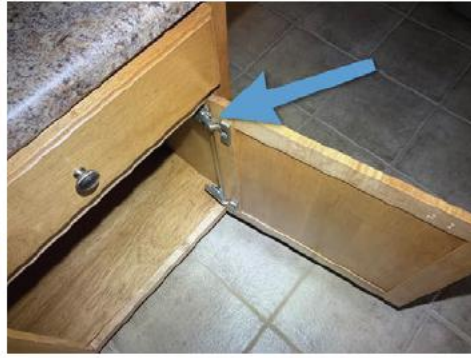
11.8.1 Countertops & Cabinets

CABINET HINGE LOOSE

One or more cabinet hinges were loose. Recommend a qualified handyman or cabinet contractor repair.

Contact a qualified cabinet contractor.

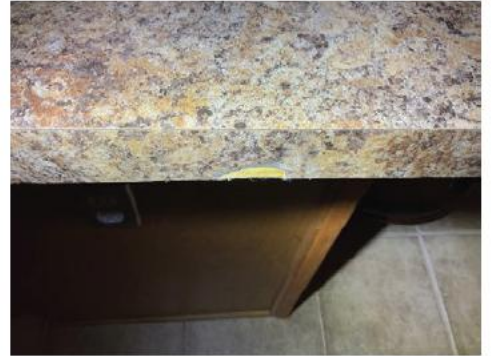
11.8.2 Countertops & Cabinets

COUNTERTOP CRACKED/CHIPPED

Countertop had one or more cracks or chips. Recommend qualified countertop contractor evaluate and repair.

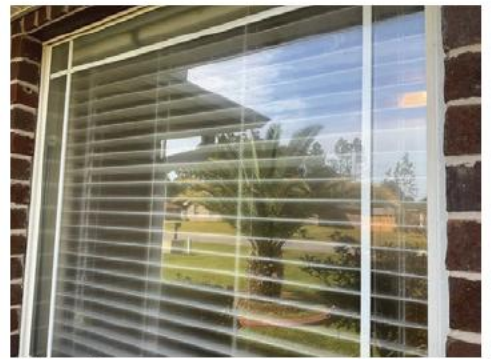
FAILED SEAL

Observed condensation between the window panes, which indicates a failed seal. Recommend qualified window contractor evaluate & replace.

Contact a qualified window repair/installation contractor.

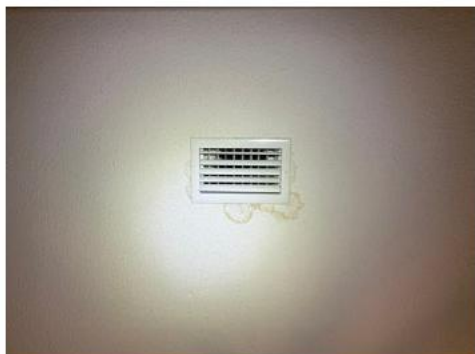
Dining Room

STAIN(S) ON CEILING

There is a stain on ceiling/wall that requires repair and paint. Source of staining should be determined. It's possible that the condensation build-up occurred prior to the recent HVAC system installation in 2018.

Contact a qualified professional.

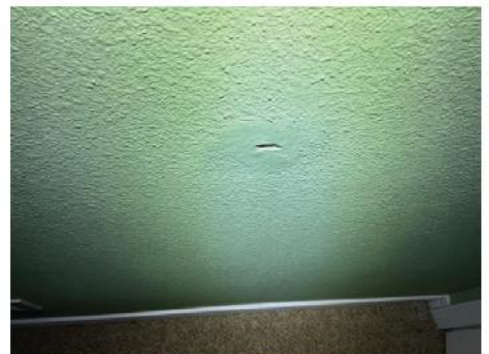
Wall had damage from doorknob. Recommend a qualified handyman or drywall contractor repair.

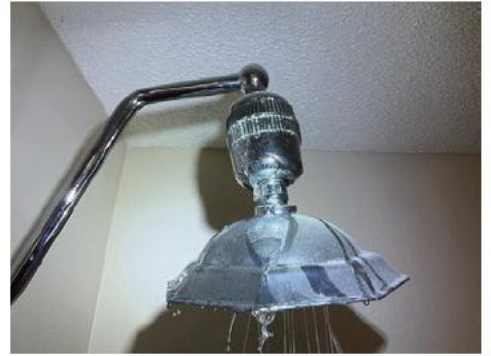
Main

LEAKING SHOWER HEAD

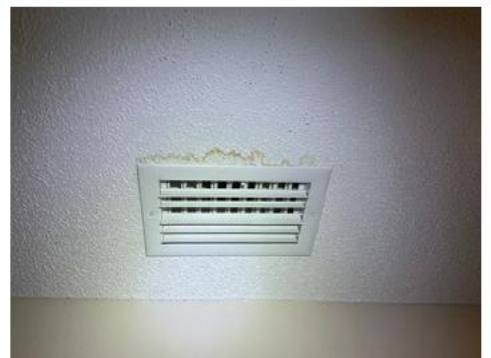
14.7.1 Ceilings

STAIN(S) ON CEILING

There is a stain on ceiling/wall that requires repair and paint. Source of staining should be determined. It's possible that the condensation build-up occurred prior to the recent HVAC system installation in 2018.

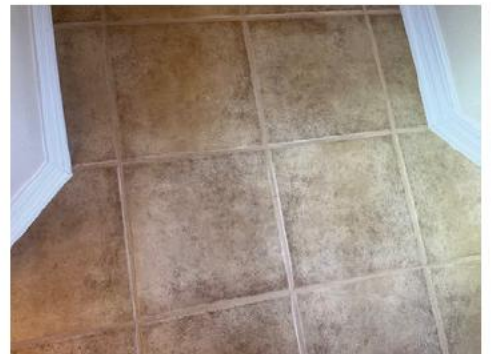
14.9.1 Floors

DAMAGED (GENERAL)

The home had general moderate damage visible at the time of the inspection. Recommend service by a qualified contractor.

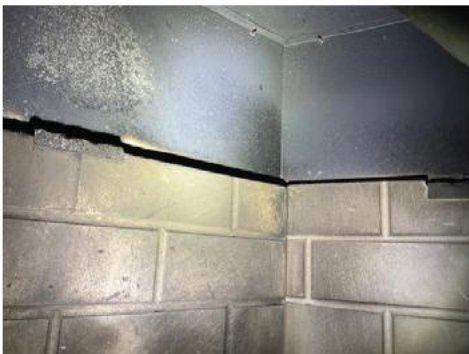
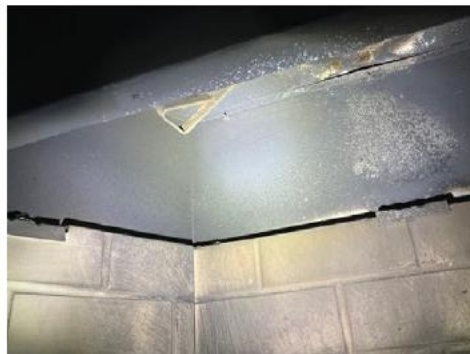
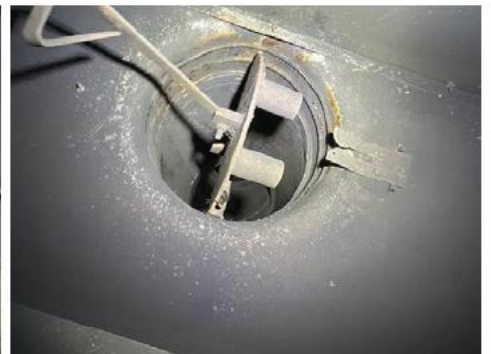
15.4.1 Solid Fuel Heating Device (Fireplace, Woodstove)

There was a notable amount of creosote buildup in the flue. Recommend a qualified fireplace or chimney contractor inspected and sweep on annual basis.

Contact a qualified fireplace contractor.
