## GENERAL HOME INSPECTION

1234 Main Street  
Navarre, FL 32566

Buyer Name  
11/25/2024 9:00AM

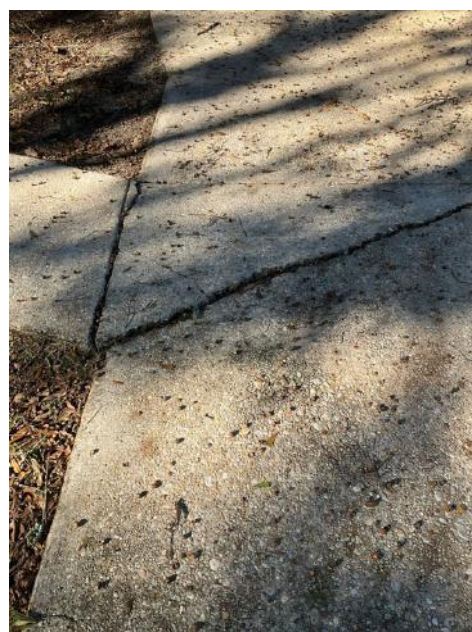
3.1.1 Walkways, Porches & Driveways

### DRIVEWAY CRACKING - MAJOR

Major cracks observed. Recommend concrete contractor evaluate and replace.

Contact a qualified concrete contractor.

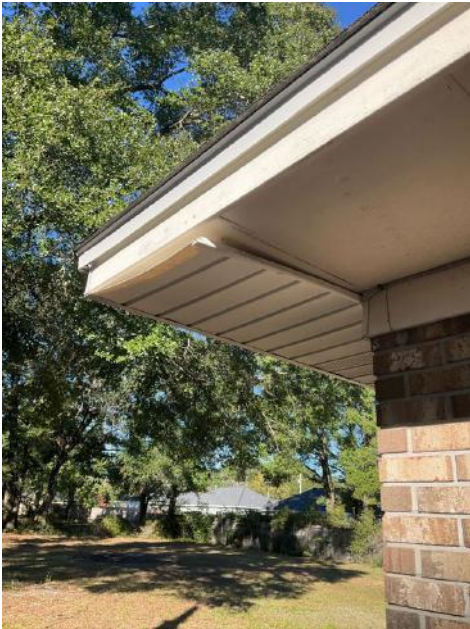
3.4.1 Eaves, Soffits & Fascia

### SOFFIT VENT LOOSE

Recommend repair or replace as needed.

Contact a qualified handyman.

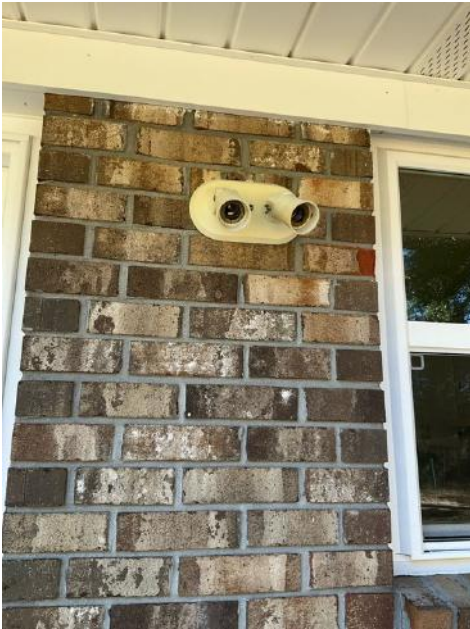
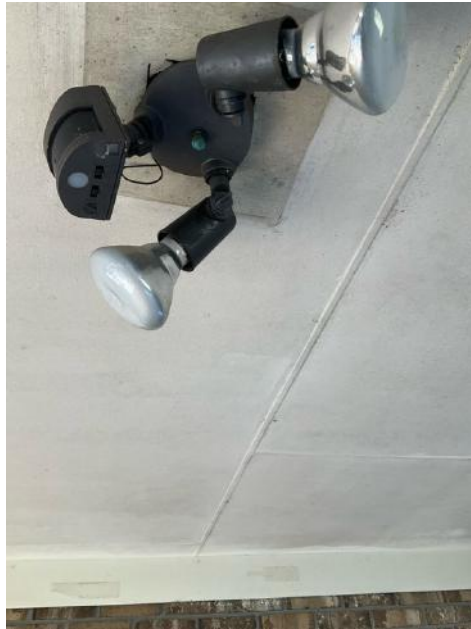
### 3.5.1 Siding, Flashing & Trim

#### **LIGHT INOPERABLE**

One or more lights are not operating. New light bulb possibly needed. If its more than a lightbulb change, recommend an electrician evaluate further.

Contact a handyman or DIY project

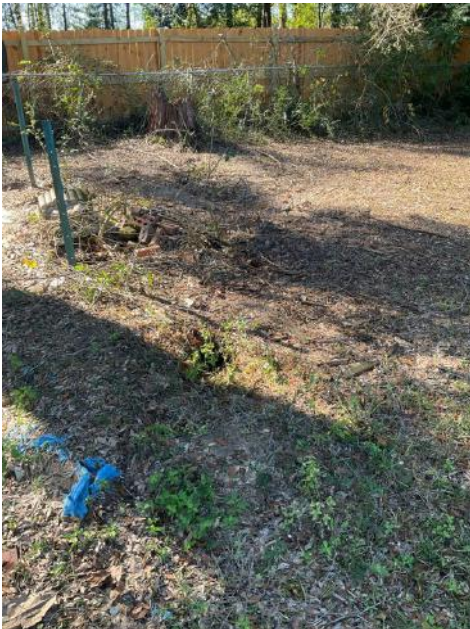
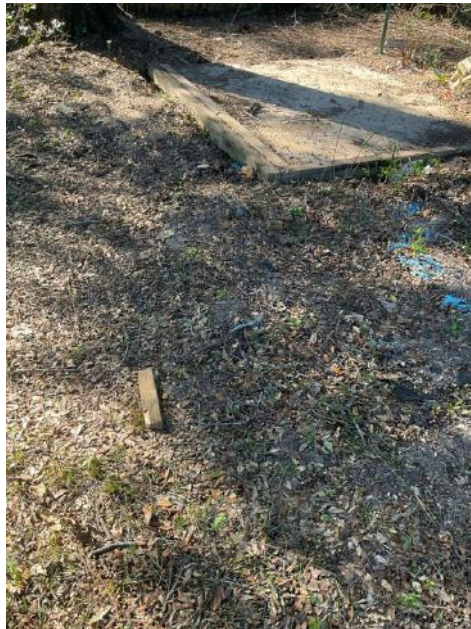
3.7.1 Vegetation, Grading, Drainage & Retaining Walls

**LOW SPOTS**

Observed low spots at various areas, recommend repair or replace as needed to allow proper water shed away from dwelling.

Contact a handyman or DIY project

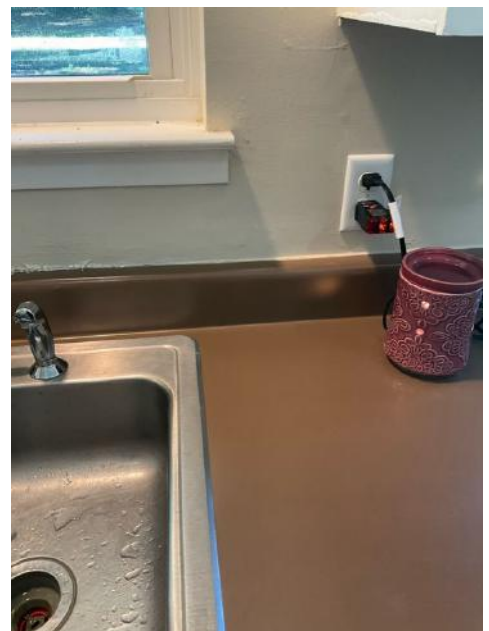
### **NO GFCI PROTECTION INSTALLED (RECOMMEND UPGRADE)**

No GFCI protection present in wet locations. Recommend licensed electrician upgrade by installing ground fault receptacles in all locations.

Contact a qualified electrical contractor.

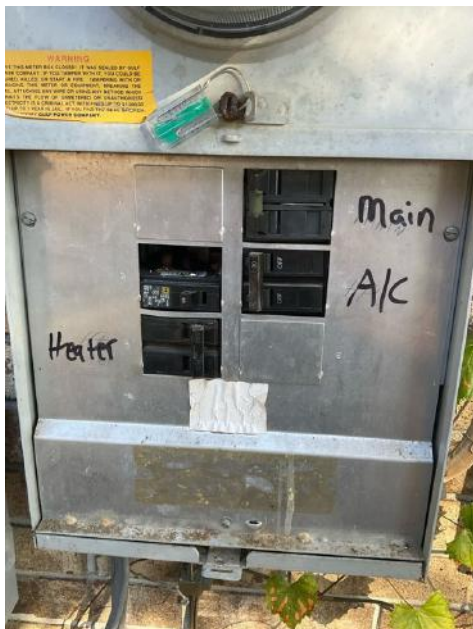
5.3.1 Main & Subpanels,

### **KNOCKOUTS MISSING**

"Knockouts" are missing on the electric panel. This poses a safety hazard and it is recommended that the opening in the panel caused by the missing knockout(s) be properly sealed by a licensed electrician.

Contact a qualified electrical contractor.

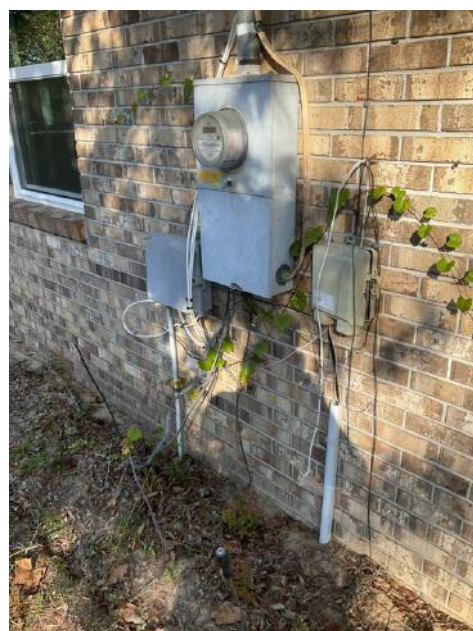
5.3.2 Main & Subpanels,

**RECOMMEND SECURING/REMOVING LOOSE ABANDONED WIRING**

Recommend securing loose wires and cables/removing abandoned wiring and cables as needed.

Contact a handyman or DIY project

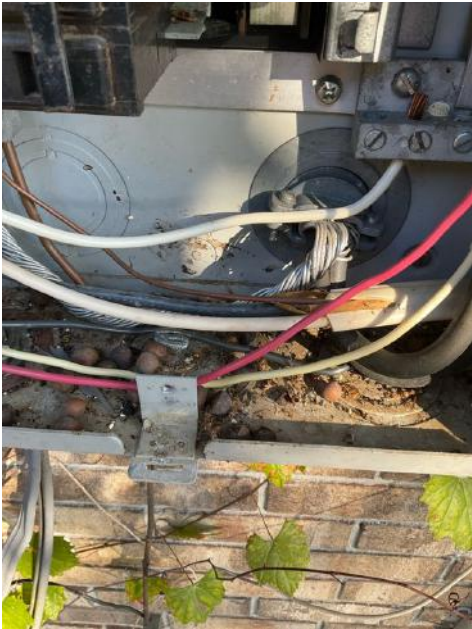
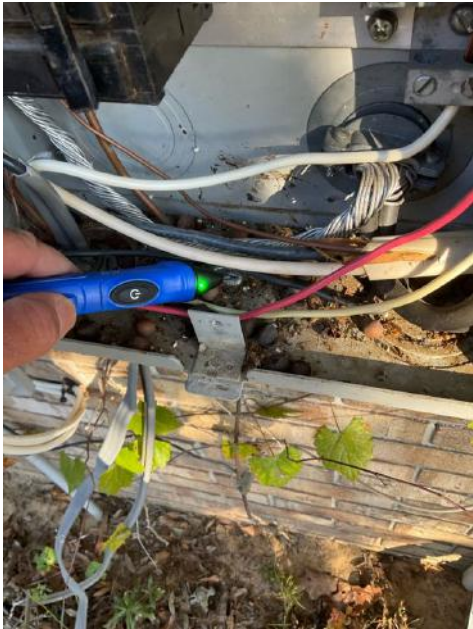
5.4.1 Branch Wiring Circuits, Breakers & Fuses

**LOOSE WIRES FOUND**

Loose wires observed at service panel, recommend securing wires to avoid any safety concerns by a qualified contractor.

Contact a qualified electrical contractor.

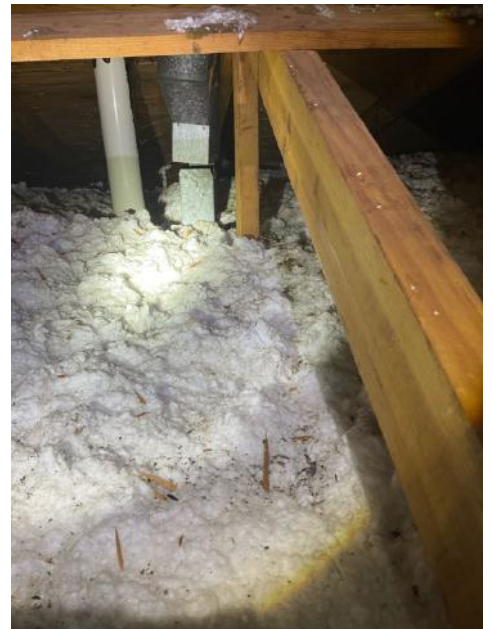
**DUCTS LOOSE**

Ductwork in the attic is loose or disconnected. Recommend repair.

Contact a qualified handyman.

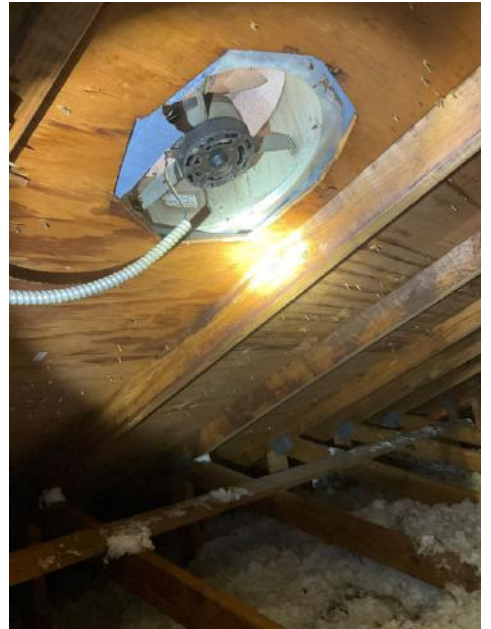
## 6.5.2 Exhaust Systems

Attic fan inoperable, recommend repair or replace as needed by a qualified contractor.

Contact a qualified professional.

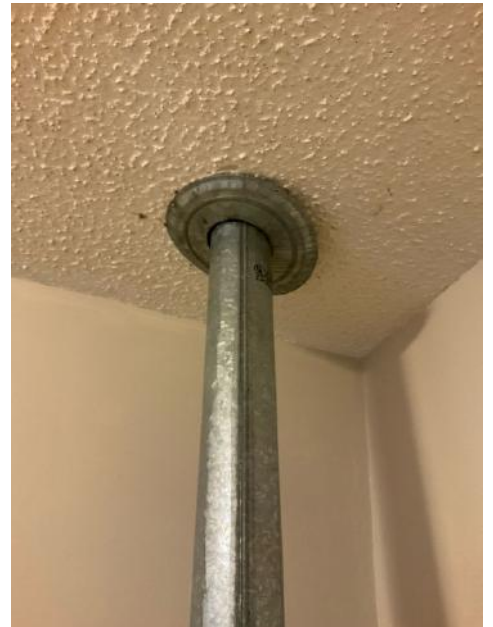
Recommend adjustment as needed.

Contact a handyman or DIY project

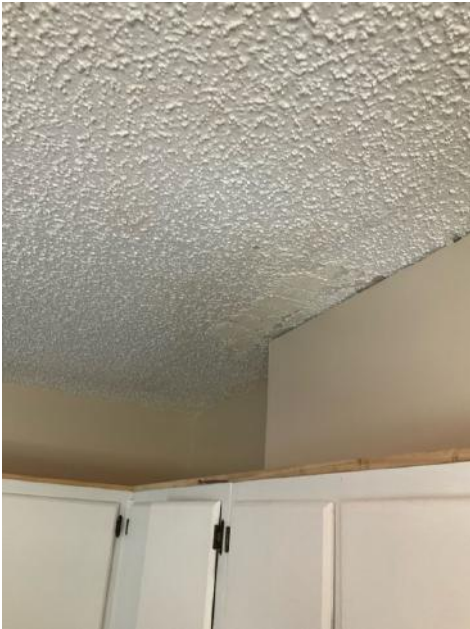
Sub-standard drywall patching observed at time of inspection. Recommend re-patching.

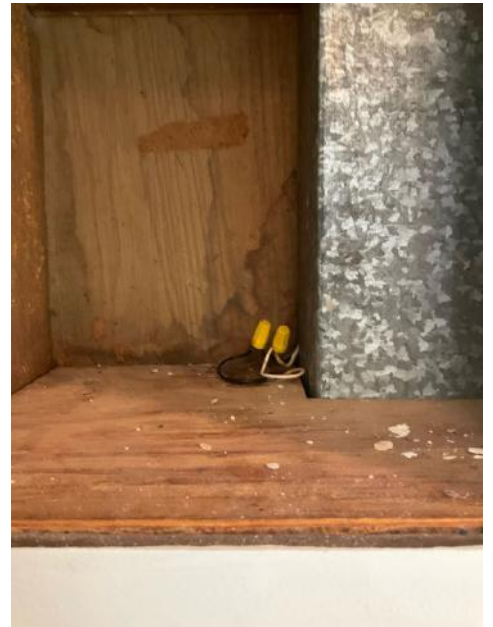
## 9.1.2 General

**LOOSE WIRES**

Recommend securing wires in junction box to avoid potential damage.

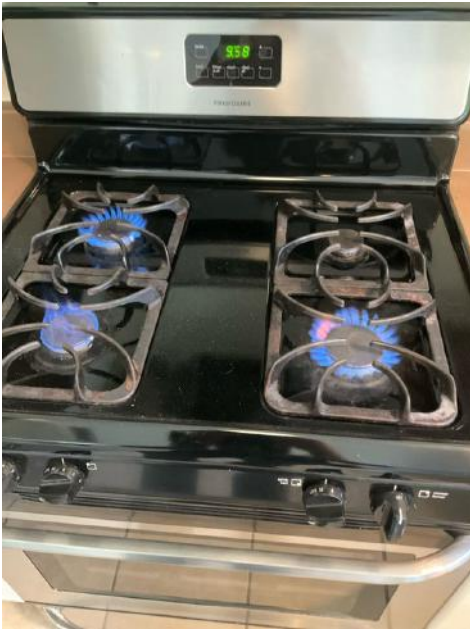
## 9.4.1 Range/Oven/Cooktop

**BURNER NOT LIGHTING**

One or more heating elements did not heat up when turned on. Recommend qualified professional evaluate & repair.

Contact a qualified appliance repair professional.

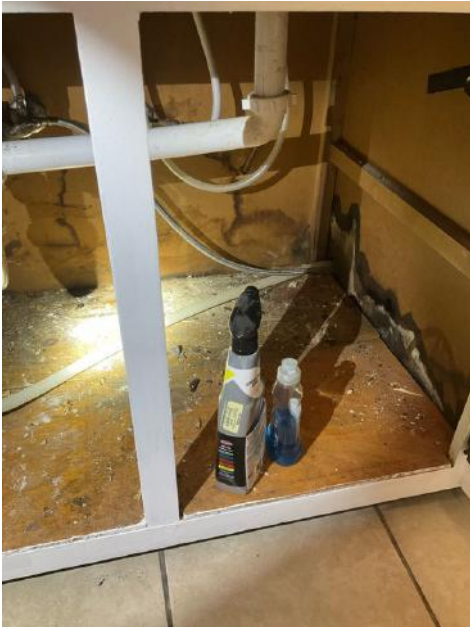
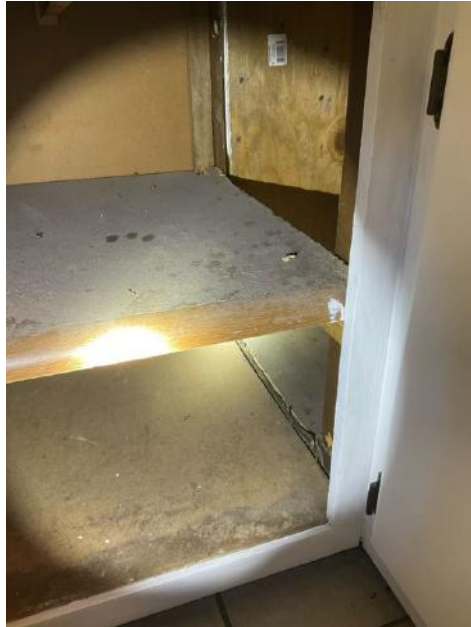
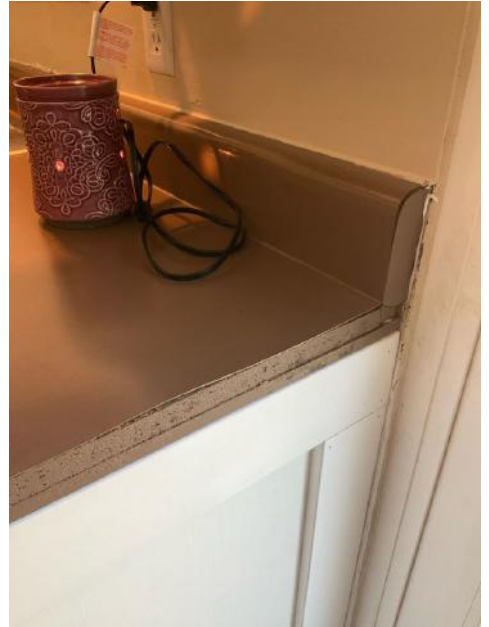
9.8.1 Countertops & Cabinets

**STAINING/DAMAGE**

There is a staining/damage at cabinets that requires repair and paint. Source of staining/damage should be determined.

Contact a qualified handyman.

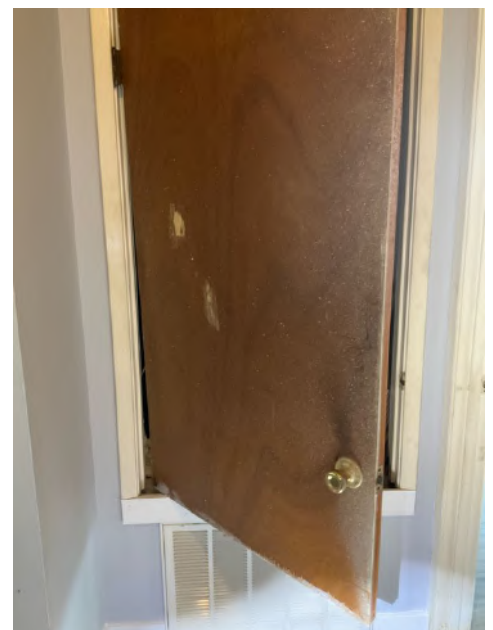
#### **HARDWARE MISSING**

Door is missing one or more pieces of hardware. Recommend replacing or upgrading.

Contact a handyman or DIY project

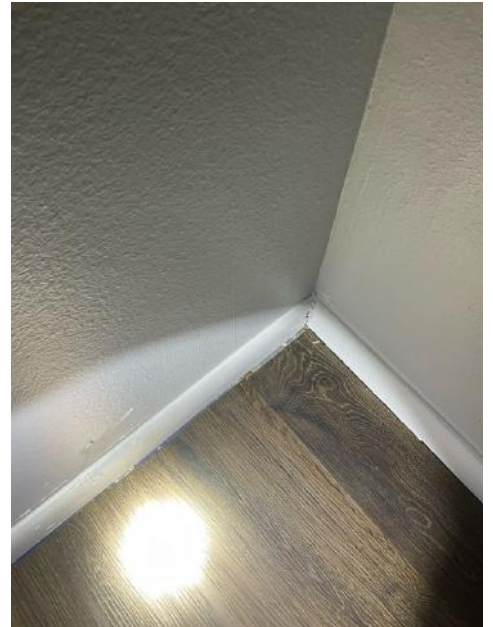
10.3.1 Floors

Observed gaps at floor edging, recommend trim to cover as needed.

Contact a qualified handyman.

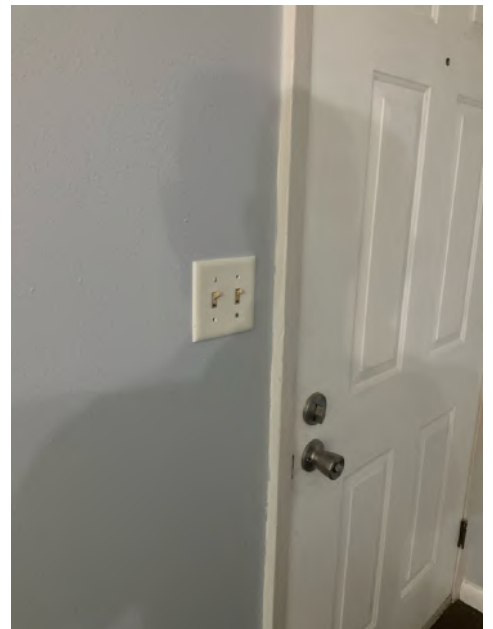
10.7.1 Lighting Fixtures, Switches, GFCI & Receptacles

**SWITCHES INSTALLED IMPROPERLY**

One or more switches are installed improperly. Recommend licensed electrician repair or replace.

Two way switch for light fan combo

Contact a qualified electrical contractor.

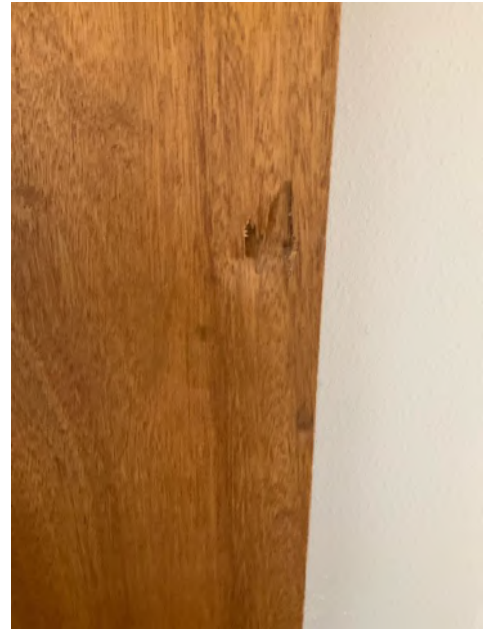
**DAMAGED**

Observed damage at one or more doors, recommend repair as needed.

Bedroom one

Contact a qualified handyman.

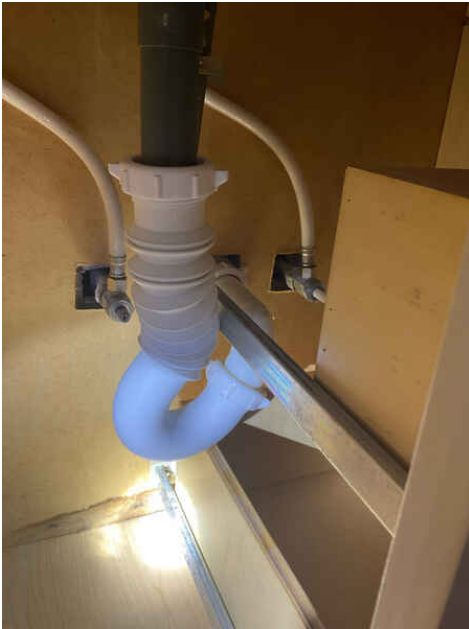
Observed substandard work at bathroom, recommend repair as needed by a qualified contractor.

Improper drain pipe installation/missing shut off valves

Contact a qualified professional.

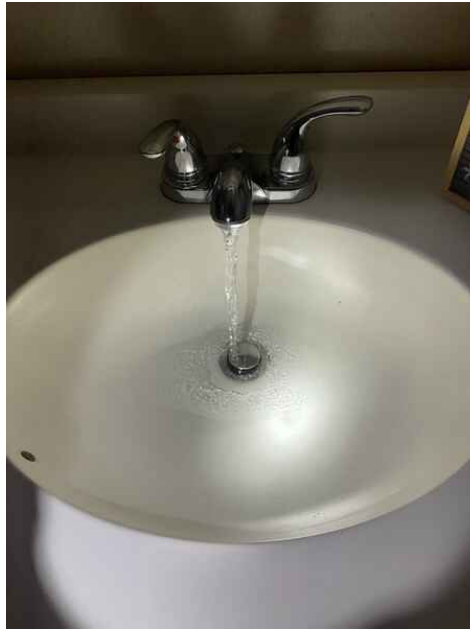
Drain Stop Inoperable

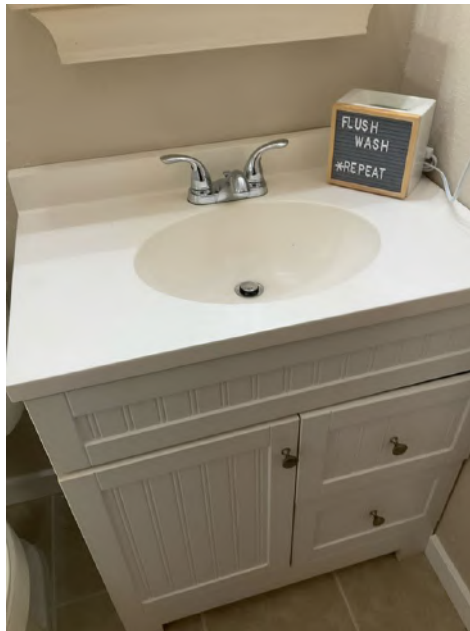
Loose vanity

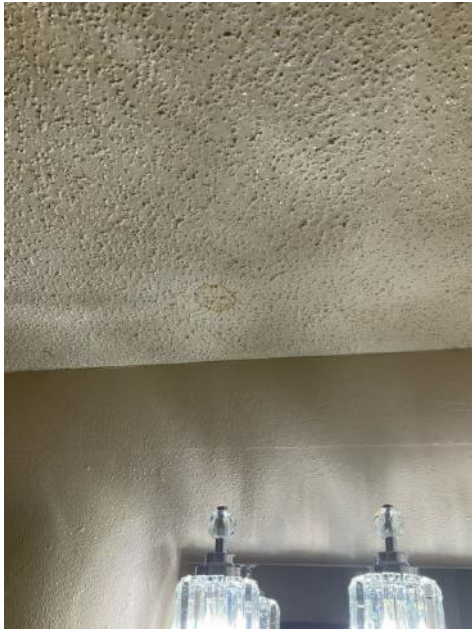
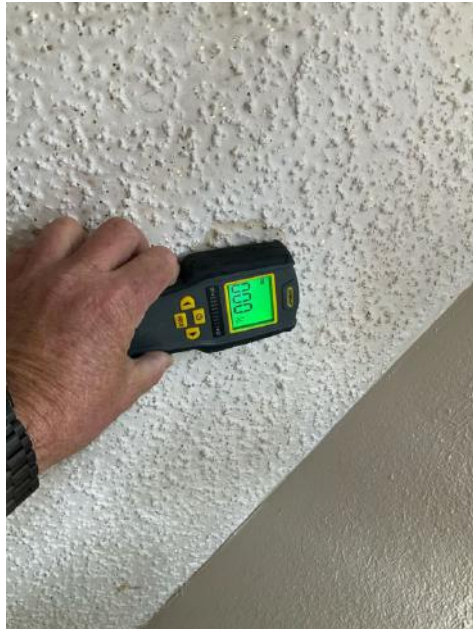
### 12.8.1 Ceilings

#### **STAIN(S) ON CEILING**

There is a stain on ceiling/wall that requires repair and paint. Source of staining should be determined.

Recommend monitoring.
