# HUD Engineering Certification Report

Prepared for: [REDACTED]

HUD Engineering Certification Report Summary

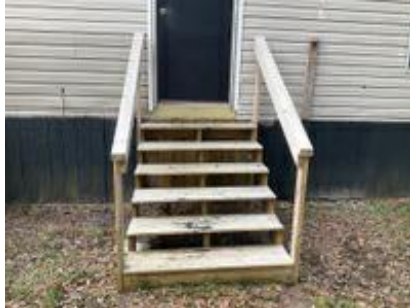
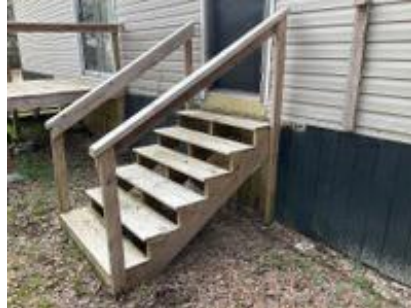
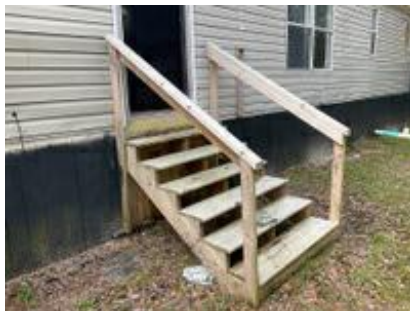
### 3.2 Images

N/A: Stairs are being supported by 2 x 4 posts next to the home and on to plastic pads, no loads are being transferred to the manufactured home.

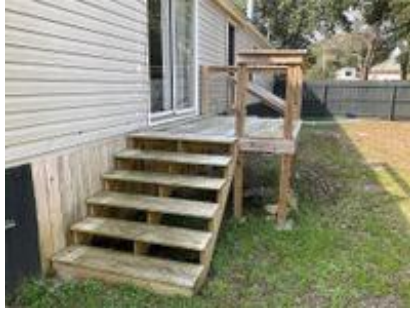
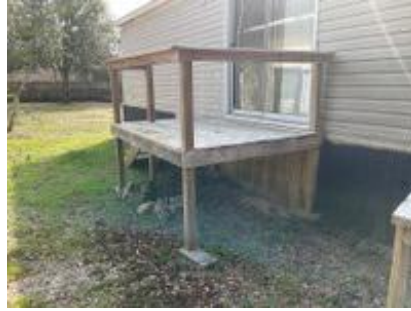
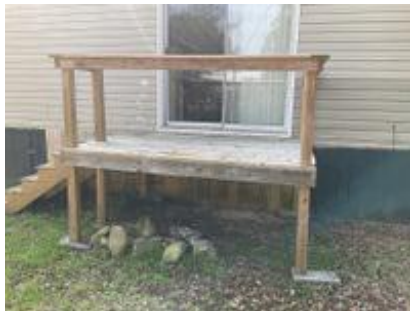
**3.8 Images**

N/A: Loads from deck are being supported by 4 x 4 posts next to the home and onto concrete pads, no loads are being transferred to manufactured home.

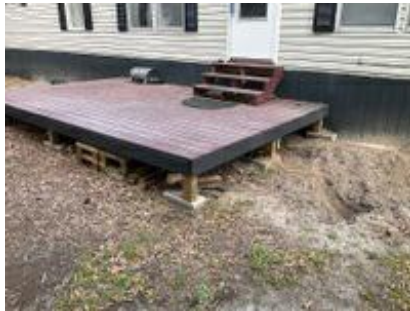
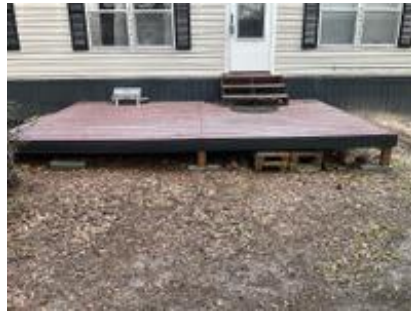
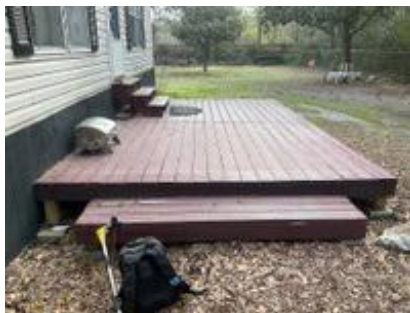
**3.14 Images**

N/A: Loads from deck are being supported by 4 x 4 posts next to the home and on to concrete pads, and no loads are being transferred to manufactured home.
